MEMORANDUM

DATE: July 21, 2017

SUBJECT: RECOMMENDATIONS CONCERNING THE CONSTRUCTION OF A
 FUMIGATION CHAMBER AT A PROCESSING FACILITY IN
 STANISLAUS COUNTY

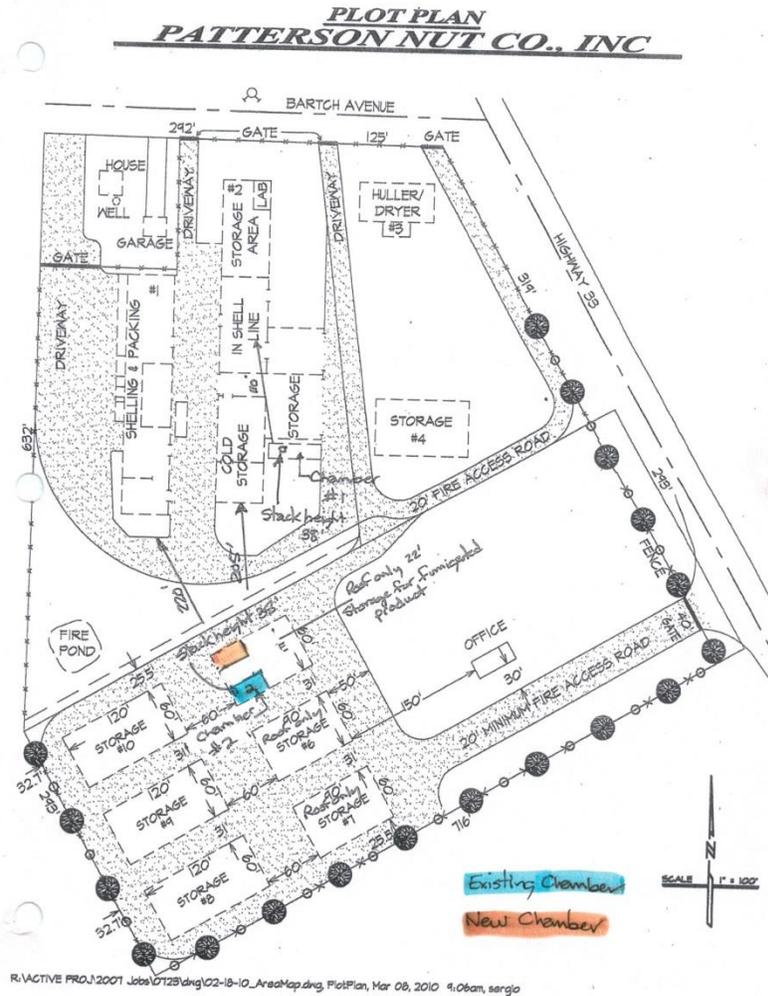
The issue under consideration was the construction of a new fumigation chamber adjacent to an existing fumigation chamber. Figure One shows the site layout and the location of both the existing chamber and the proposed site of the new chamber. There is another existing chamber (marked as “Chamber #1” on the site layout map), but it is not involved with any issues of the proposed new chamber.

The existing chamber (marked as “2” and highlighted in blue on the site layout map) has been fully permitted by Stanislaus CAC. The proposed chamber (highlighted in orange on the site layout map) would be under the same pole barn as Chamber 2 and would essentially be a duplicate of Chamber 2. Our walk-around of Chamber 2 did not uncover any obvious issues that were non-compliant with the Department of Pesticide Regulation’s “Suggested Permit Conditions: Methyl Bromide Commodity Fumigation 1994” (“MBr Permit Conditions”) document.

Figure One: Site Layout. Orange: New Chamber, Blue: Existing Chamber
